CIVIL AERONAUTICS BOARD
ACCIDENT INVESTIGATION REPORT

AIRBORNE TRANSPORT, INC.—MIAMI, FLORIDA, DECEMBER 28, 1948

The Accident

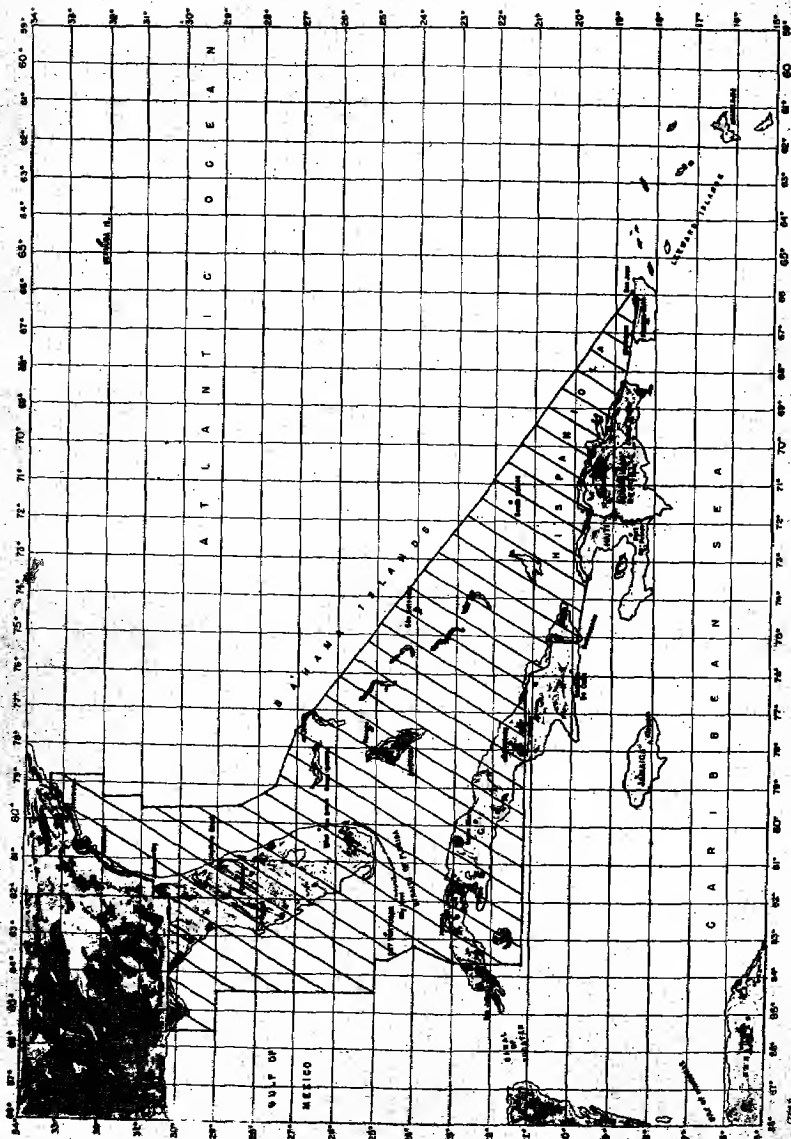
AREA SEARCHED

9. An extensive search by the Search and Rescue Agency of the United States Coast Guard, utilizing facilities of other services, civil aircraft and ground parties, failed to locate any trace of the missing aircraft and was terminated six days later.
